Assessment diagnostics of the functionality of composite insulators operating in the 150kV power network of Crete

N. Mavrikakis^{*1,2}, K. Siderakis² and E. Koudoumas³

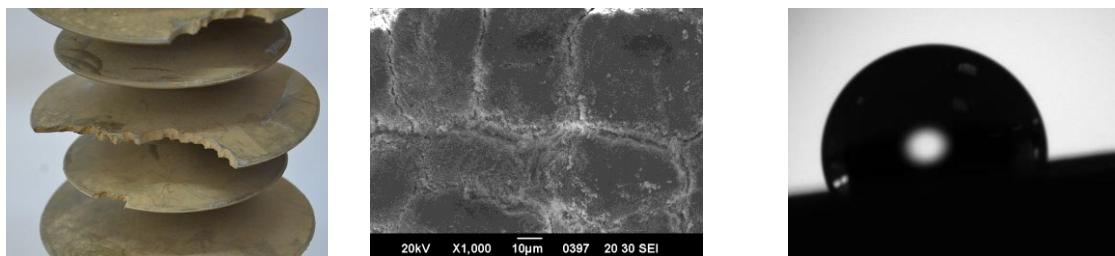
Figure 1: Diagnostic Techniques for evaluating the condition of field composite insulators

(a) Field Inspection – Bird Attack in a field composite insulator. (b) SEM image of a degraded field composite insulator. (c) Evaluation of field insulator hydrophobic performance.
